TECHNICAL REPORT REMR-CO-3

**CASE HISTORIES OF CORPS BREAKWATER
AND JETTY STRUCTURES**

SOUTH ATLANTIC DIVISION

Francis E. Sargent

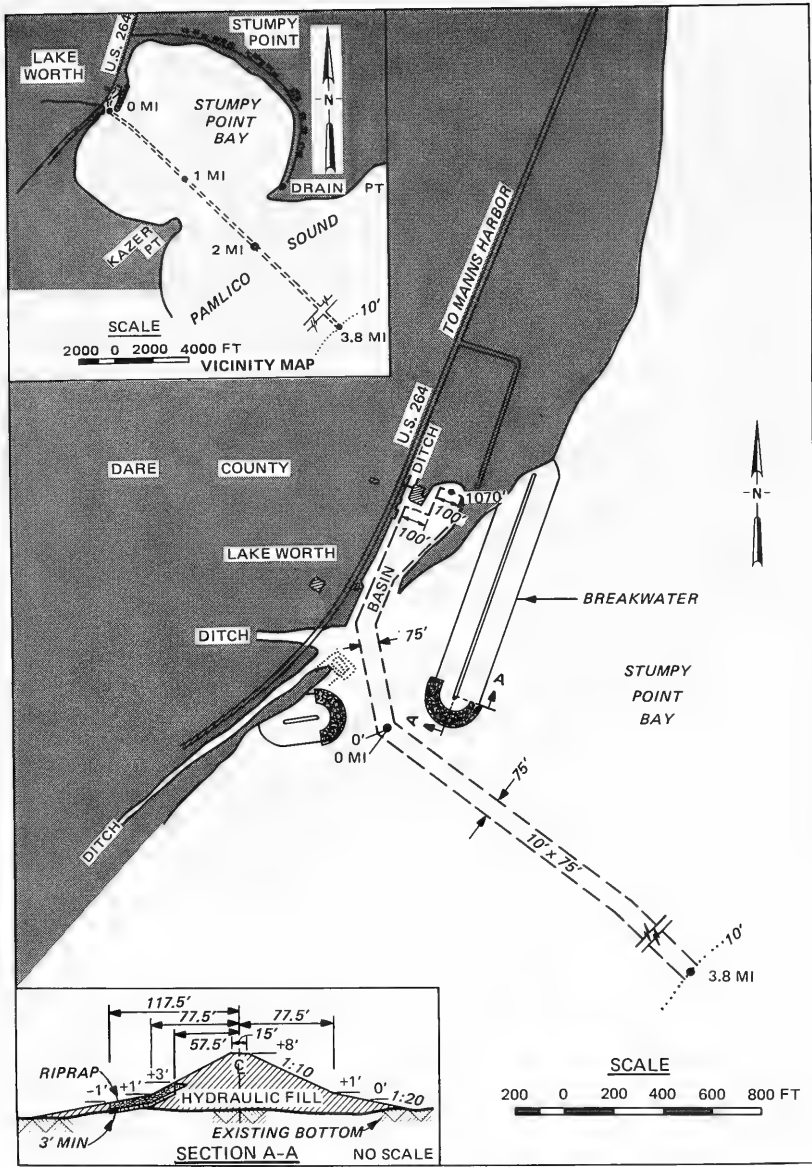
Figure 4. Stumpy Point Bay, North Carolina

1974	A reconnaissance survey was made to determine the severity of erosion to the breakwaters. It was found that the riprap protected sections were functioning satisfactorily but that the fill material adjacent to the riprap sections had substantially eroded. Maximum vertical scarps of 7, 3, and 3 ft, respectively, were noted on the bay and harbor sides of the north breakwater and bay side of the south breakwater. The erosion on the north breakwater was on directly opposite sides of the breakwater with only 30 ft of original material separating the narrowest point. It was felt that "the southeasterly wind with its associated fetch is very erosive to the breakwaters on both sides of the dredged channel."
1985	Neither repairs nor maintenance has been carried out since the breakwaters were originally constructed.

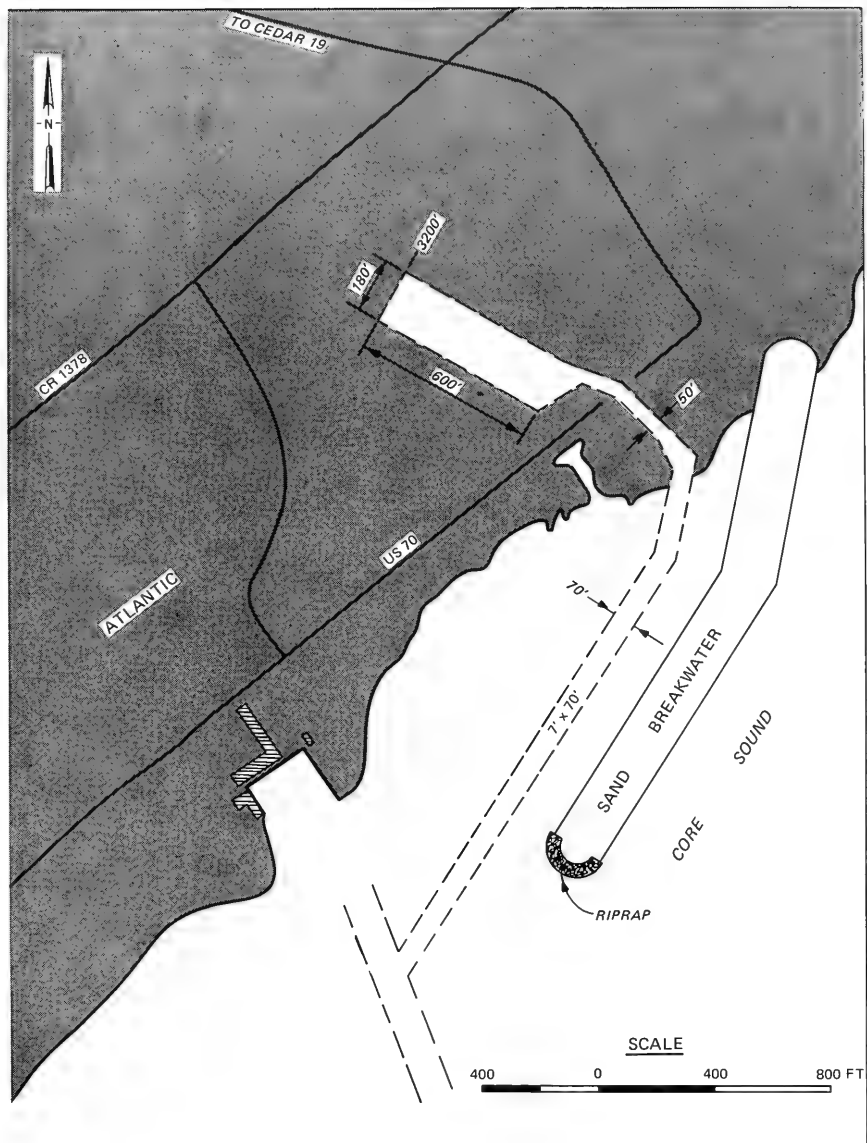
Figure 8. Atlantic Harbor of Refuge, North Carolina

<u>Date(s)</u>	<u>Construction and Rehabilitation History</u>
1971- 1972	A 2,000-ft-long sand breakwater (Figure 8) with a riprap head was constructed in February 1972 as part of the Harbor of Refuge project. Material dredged from the access channel was used for the breakwater. A tentative design section called for a crest width of 15 ft at an elevation of +8 ft mlw, with side slopes of 1V:10H above mlw and 1V:20H below. The head of the breakwater would have a 3-ft-thick riprap section from -1 to +3 ft mlw. This design section was similar to the one used on the Stumpy Point Bay breakwaters. Estimated quantities were 46,500 cu yd of sand, 3,232 tons of stone, and 6.5 acres of grass (to hold the sand in place). The estimated total cost was \$51,400.
1973	Erosion had occurred along a 400-ft section of the southeastern face of the breakwater. The erosion extended from 35 to 60 ft into the embankment, creating an escarpment of about 3 ft, and the planted grass had been destroyed in this area. Also, the stone protection on the south end of the breakwater (previously covered with sand) had become uncovered, displaced, and scattered. The sand fill behind the stone apparently eroded away first, undermining the rock and subsequently displacing it.

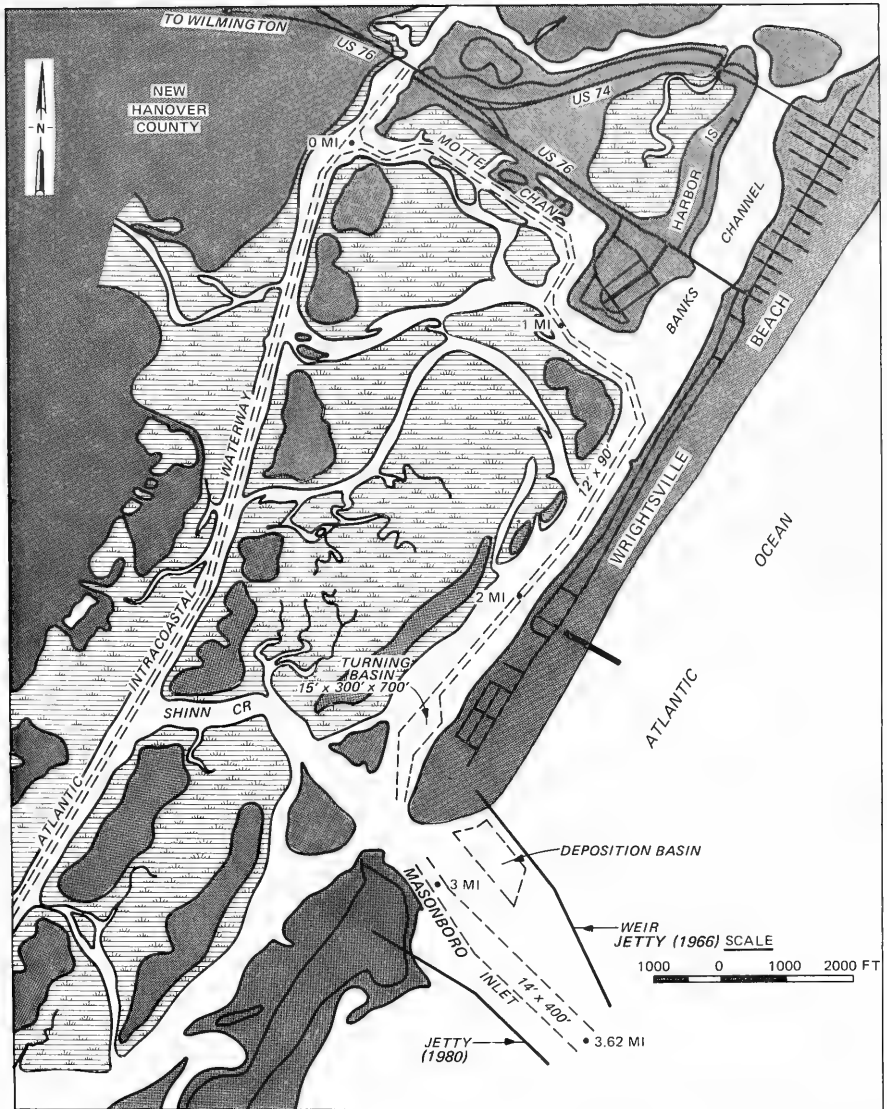
Figure 10. Masonboro Inlet, North Carolina

1985	Presently, the south jetty is in good condition; whereas, the north jetty, which was constructed of smaller size armor stone, is in need of repair work in several areas showing localized armor stone damage.

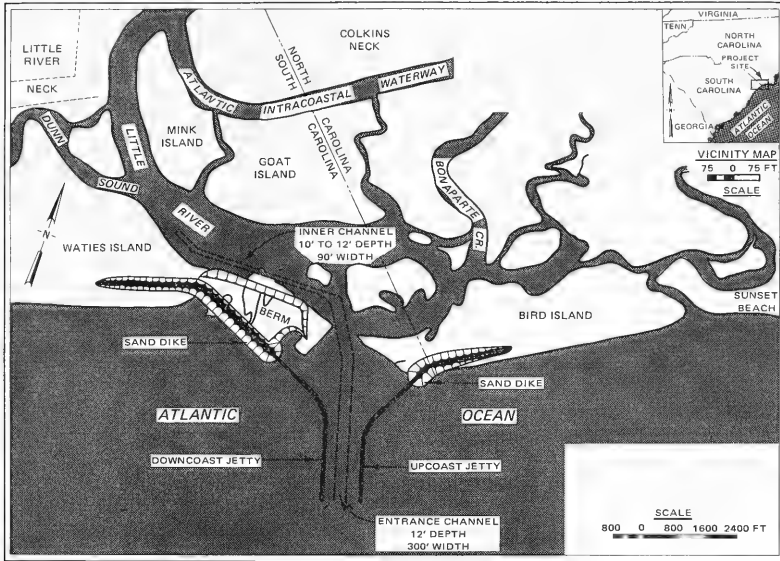
Figure 14. Little River, South Carolina

1986	<p>A visual examination of the structures indicated some displaced stone along the weir section of the north jetty. Surveys also revealed scour holes at the head of the north jetty and along the channel side of the south jetty. No apparent jetty damage was indicated above the water surface. Damage along the toe of the structures, if any, is unknown.</p>

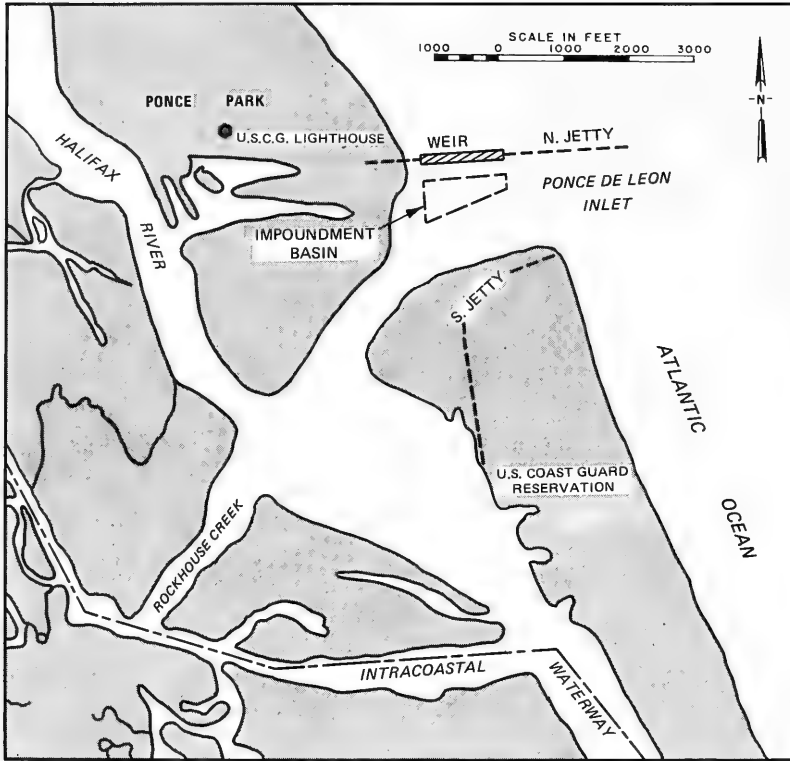
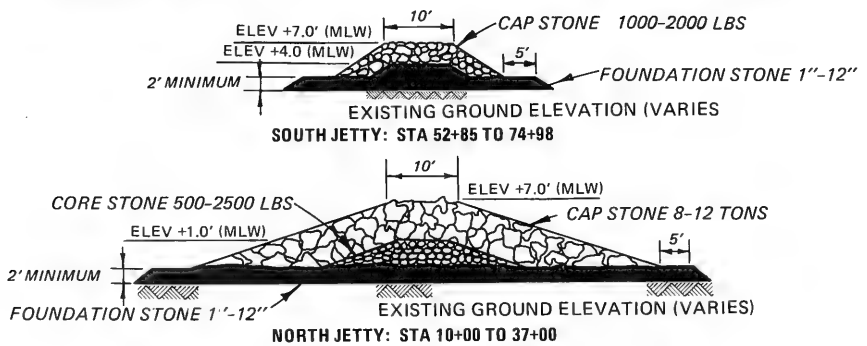
Figure 29. Ponce de Leon Inlet, Florida

Date(s)	Construction and Rehabilitation History
1981	Erosion at the root of the north jetty required placing stone over a 375-ft section of the existing jetty beginning 125 ft from landward end. The repair cross section consisted of a 1.5-ft layer of 1- to 50-lb bedding stone, a core of 30- to 1,000-lb stone, and 0.5- to 2-ton capstone. Side slopes were 1V:2H with a 5-ft crest width and crest elevations varying from +9 to +12 ft mlw. Additionally, 1,150 tons of bedding stone, 1,970 tons of capstone, and rearrangement of stockpiled core stone were used in the repair.
1982- 1983	The north jetty weir section was closed using core and armor stone (no details). Armor stone size and cross-section geometry were similar to those for the existing rubble-mound section at the seaward end of the weir section.
1985	The jetties are presently in good condition except for some damage on the north jetty head because of a recent storm and continued erosion at the root of the jetty.

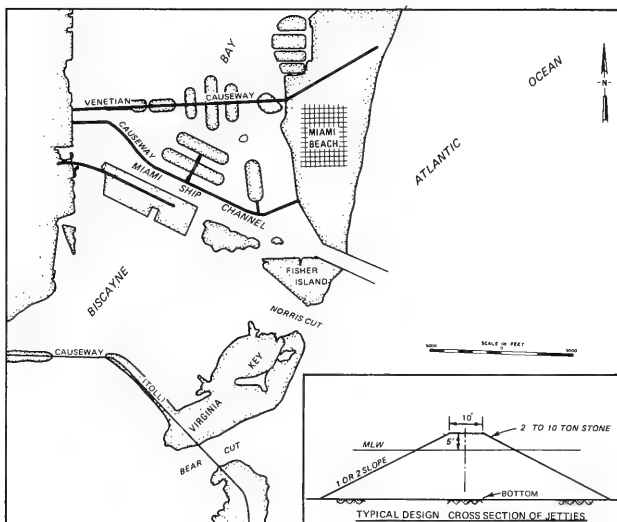
Figure 37. Miami Harbor, Florida

1985	Presently a 38-ft-deep by 400-ft-wide channel is maintained between the jetties. Except for the sand-tightened portion (1983), the jetties have not been repaired since 1934 and, although in poor condition, are still functioning properly.

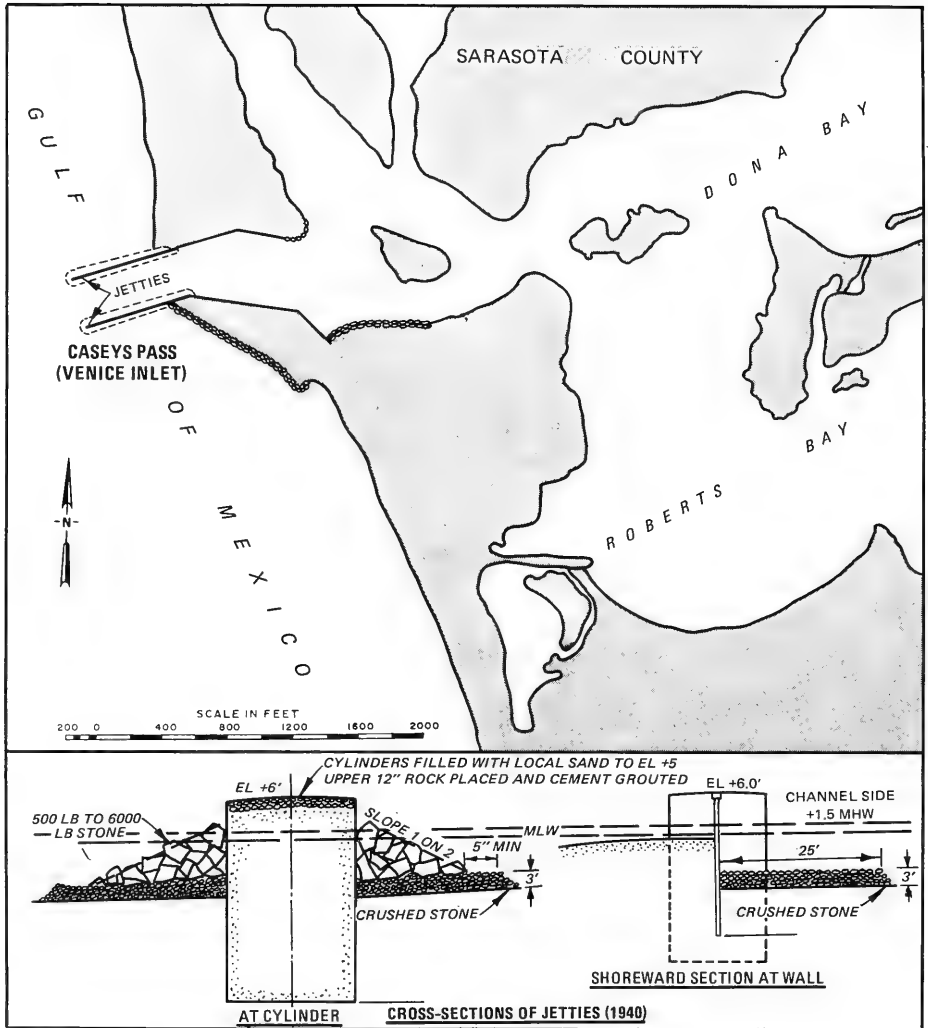
Figure 39. Casey's Pass, Florida

1950-1951	Jetty surveys showed that the heads and seaward sides of the jetties needed repairs. The channel side of the north jetty needed repair because of the proximity of the channel causing scouring at the toe.
1955	Repairs were made to the seaward end of the south jetty which was in a "severely damaged" condition. A total of 650 tons of 3- to 6-ton cover stone was placed on a 2-ft-thick foundation blanket of 2- to 6-in. stone at a total cost of \$6,500. Repairs were also made to the collapsed concrete caps on the 1st and 8th caisson from its seaward end. Nearly 3/4 of the first caisson was severely damaged, and 3- to 6-ton cover stone was placed to +6 ft mlw with a 10-ft crown width. The upper 4 ft of the 8th caisson was filled with stone, and the upper foot of this was capped with concrete grout.
1963	Repairs to the concrete cylinder caps and jetty stone/rock revetments were made at a cost of \$30,000. At this time, the channel was dredged to a depth of -9 ft mlw. Along the exposed seaward sections, 3- to 6-ton capstone totaling 615 and 770 tons was placed on the north and south jetties, respectively, and approximately 20 capstones were reset. Several of the seaward cylinders were repaired. Their caps and sand were removed to -1 ft mlw, replaced with the broken pieces of the cap and 20- to 200-lb stone, and grouted with concrete throughout the upper 18 in. of stone.

1978	<p>Repair to jetties consisted of resetting stone and adding 6- to 12-ton stone (75 percent > 10 ton) on the outer 200 ft of the jetties and 2- to 6-ton stone on the next 450 ft of the jetties as needed to solidify the structure.</p>
1985	<p>The jetties are in good condition except for their head sections which are in need of some repair.</p>

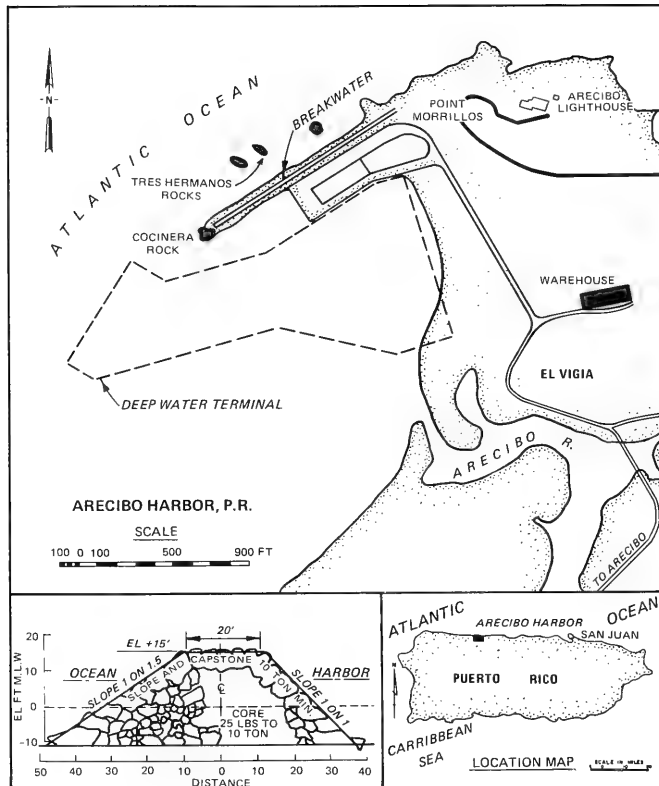
Figure 41. Arecibo Harbor, Puerto Rico

1983	A field inspection and a condition survey were made to identify damaged areas for rehabilitation purposes. The general damage (Figure 42) was above mlw, and the ocean-side slope of the submerged part of the structure had increased to 1V:2H or greater. In particular, about 160 ft of the seaward end had subsided to approximately mlw. Several areas on the trunk section had unprotected core stone on either side of the structure.
1984	Rehabilitation of the breakwater consisted of rebuilding the outer end of the breakwater and restoring damaged sections by placing about 42,000 tons of armor stone, ranging in size from 11 to 29 tons (Figure 42). A double layer of armor stones was provided on the seaward side of the structure along a reach beginning about 350 ft from the shore end of the breakwater and extended toward the outer end, a distance of 450 ft. A double layer of armor stone was placed on both sides of the structure for the next 265 ft. The remaining 155 ft, at the seaward end of the structure, was rebuilt to +15 ft mlw, as were the other sections. The crest of the damaged sections was restored to a width of about 26 ft for the first 800-ft reach. The crest of the outer 420-ft section was widened to about 36 ft, flaring out to about 50 ft at the extreme outer end. Armor stone slopes for the ocean and harbor sides were 1V:2.3H and 1V:1.5H, respectively. Based on utilizing local stone, the cost of the work was estimated to be \$3,900,000. The design analysis used was the

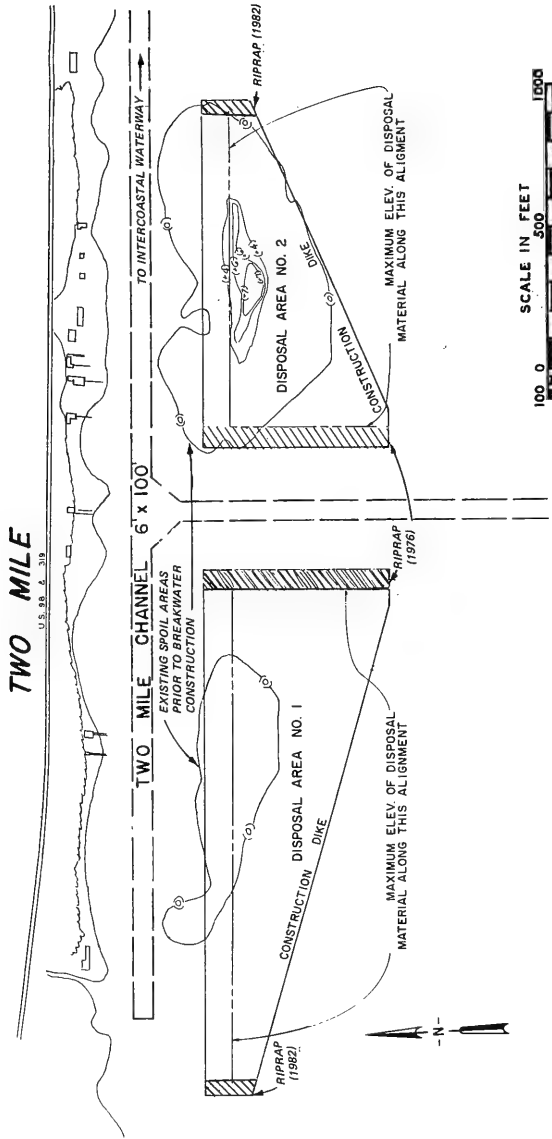
Figure 45. Two Mile breakwaters, Florida

1982	<p>The outer ends of the two breakwaters had been eroding and were revetted with stone left over from the original construction.</p>
1985	<p>The breakwaters are presently in good condition.</p>

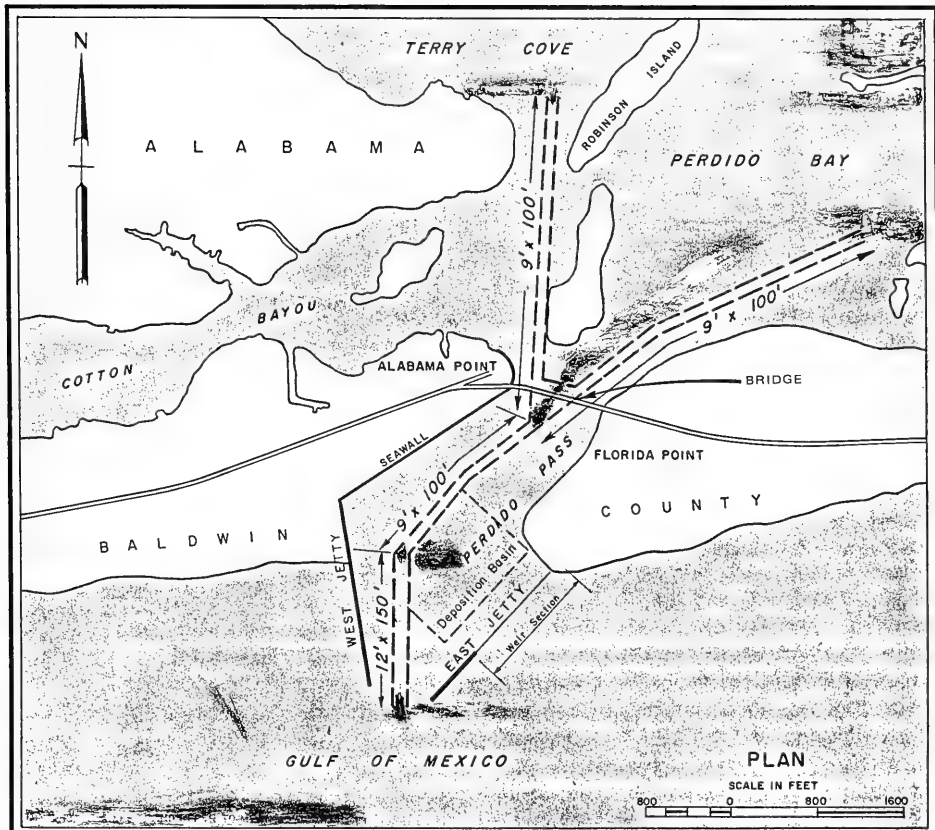
Figure 56. Perdido Pass, Alabama

1985	The jetties are presently in good condition.
